LAKE SEBAGO DAM
ROCKLAND COUNTY
NEW YORK
INVENTORY NO 772

PHASE I INSPECTION REPORT
NATIONAL DAM SAFETY PROGRAM

National Dam Safety Program. Lake Sebago
Dam (772), Lower Hudson River Basin,
Rockland County, New York. Phase I
Inspection Report.

11 19 SEPTEMBER 1978

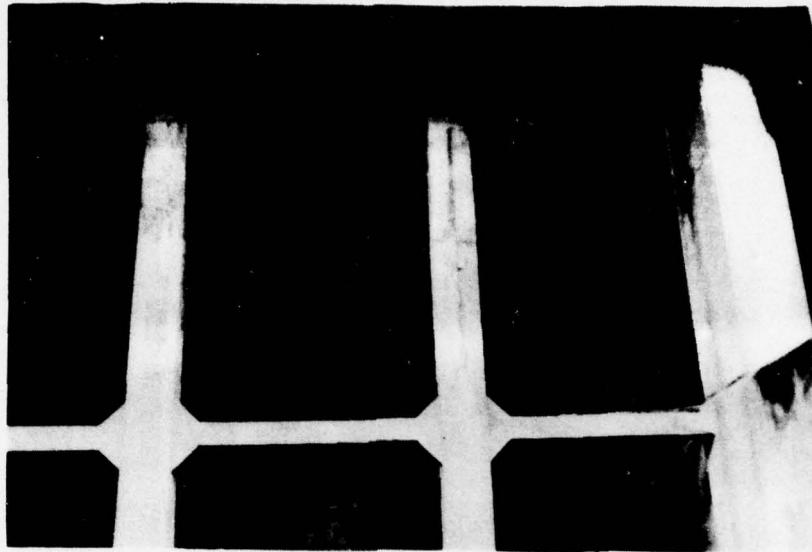
1. View of dam and bridge piers from below dam.

Photographs 1 and 2 show structural elements of the bridge across the dam. The bridge cross beams are seated onto the dam ogee section as shown in Photograph 3. Cold pour joints can be seen in this photograph. The upstream face of the dam is shown in Photograph 4. This reservoir side of the dam was inspected by boat. A number of spalled areas in the bridge superstructure were noted. Reddish clay material was found to be discharging from a drain on the east abutment. The red color of the water discharging from this drain also suggests iron oxide from the material behind the abutment precipitating as pressure is relieved. However, the precipitate has a slippery feel that suggests a clay material carried by the seepage. Further investigations should be made to determine the source of this material. No seepage or unusual conditions were located in the area below the dam.

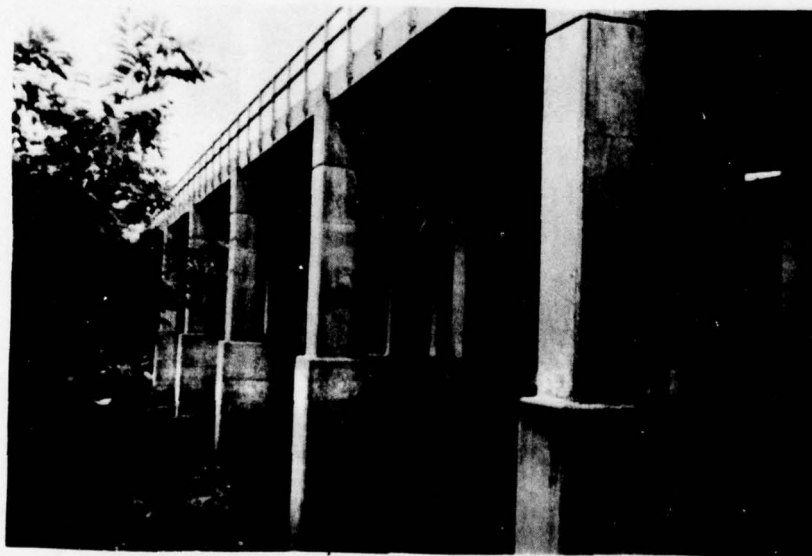
2. View across back of dam.

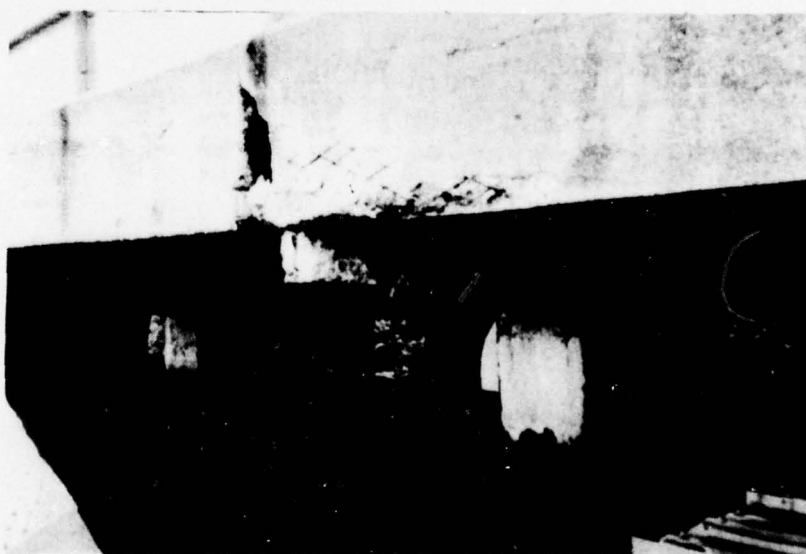
4. Closeup of spalled bridge area upstream of dam.

VISUAL EXAMINATION OF	OBSERVATIONS	REMARKS OR RECOMMENDATIONS
CONCRETE WEIR	Dam acts as ogee crest spillway between bridge piers. Good condition; clear.	
APPROACH CHANNEL	Reservoir impoundment.	
DISCHARGE CHANNEL	Clear.	
BRIDGE AND PIERS	Needs work. Spalling and cracking of members.

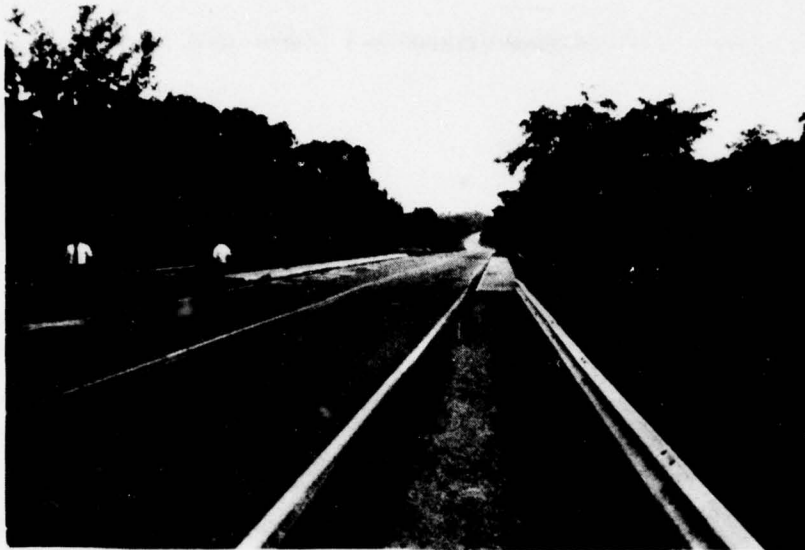
5. Seven Lakes Parkway road across dam.

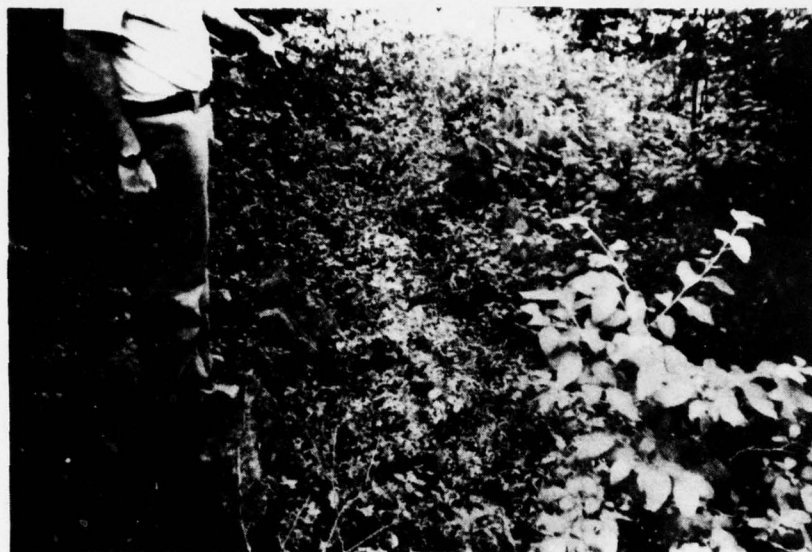
9. Earthen embankment location with large amount of seepage.

The core wall embankment sections and related impounding segments, appear generally to be in good condition with no indication of structural instability or deterioration, although considerable seepage is occurring through in one area. It is recommended that, at the time studies for the gravity dam are undertaken, field explorations and engineering studies also be performed to ascertain the area of embankment seepage and develop a method for correction of the condition.

It is recommended the owner of the dam investigate the seepage in the embankment section to determine the extent of seepage and source of seepage. The embankment has a large number of trees growing on it which should be removed. Seepage may be related to

tree growth where seepage paths may have developed along root systems. If this is the case, it may be necessary to make a relatively comprehensive evaluation of alternatives to eliminate the seepage and improve the condition of the embankment.

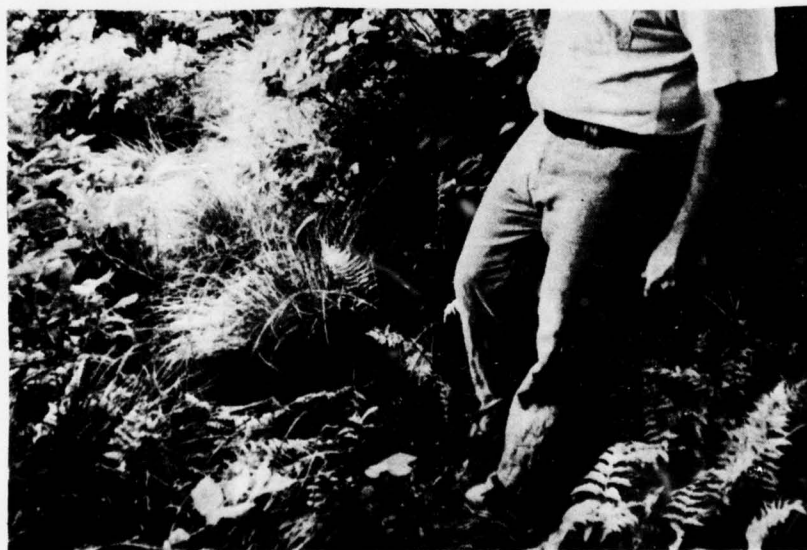
10. Marsh area below seepage.

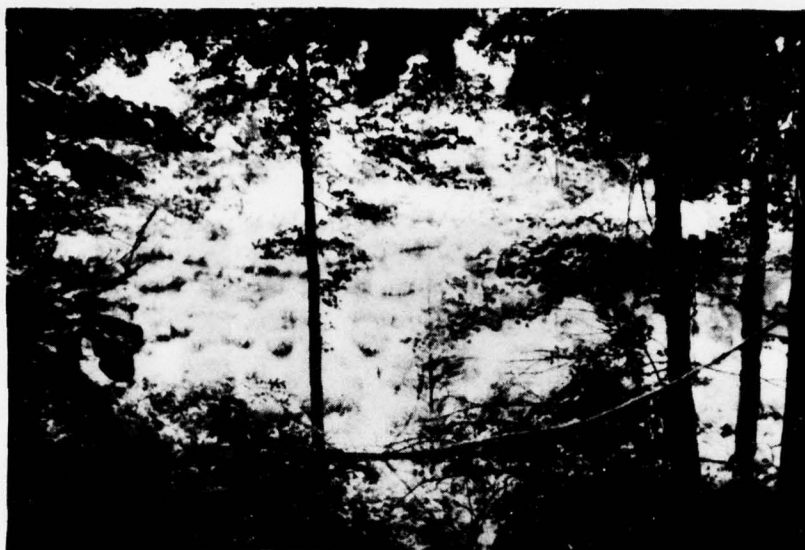
11. Detail of wetness area above marsh.

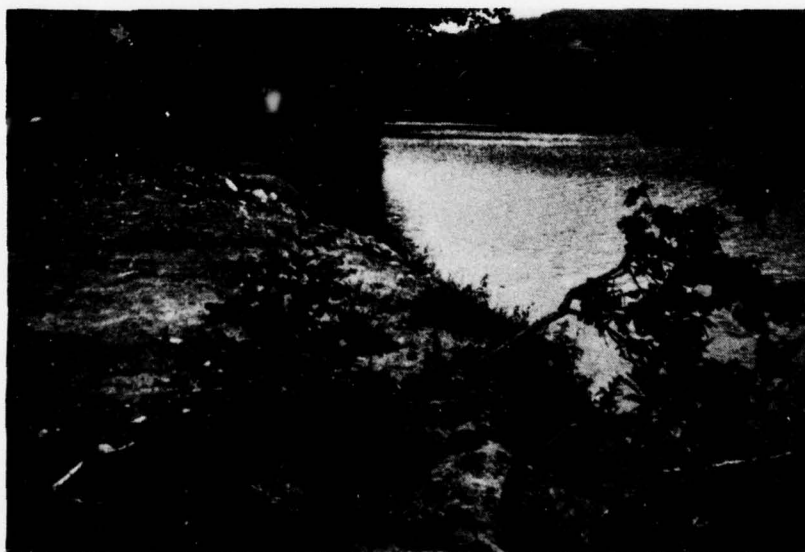
12. Closeup of upstream embankment above seepage. Notice some of the clay material being deposited into reservoir to stop seepage.

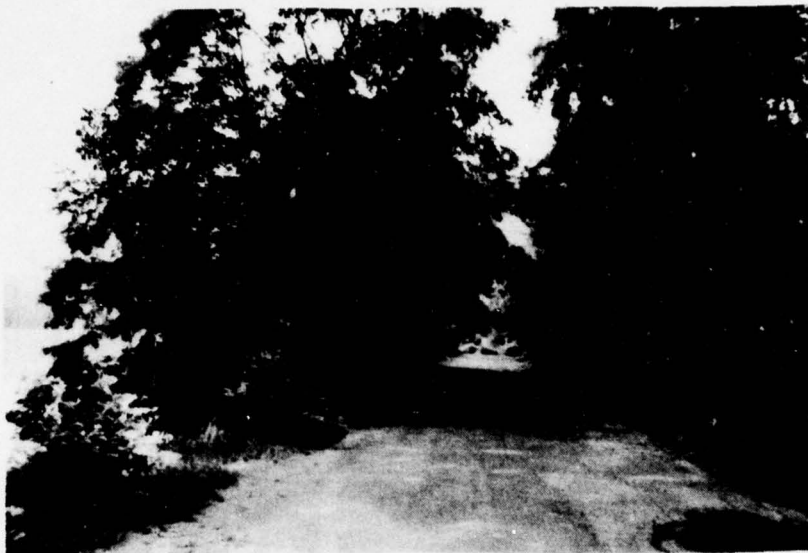
13. Treed area along top of embankment
near location of seepage.

The embankment has a large number of trees growing on it which should be removed. Seepage may be related to tree growth where seepage paths may have developed along root systems. If this is the case, it may be necessary to make a relatively comprehensive evaluation of alternatives to eliminate the seepage and improve the condition of the embankment.

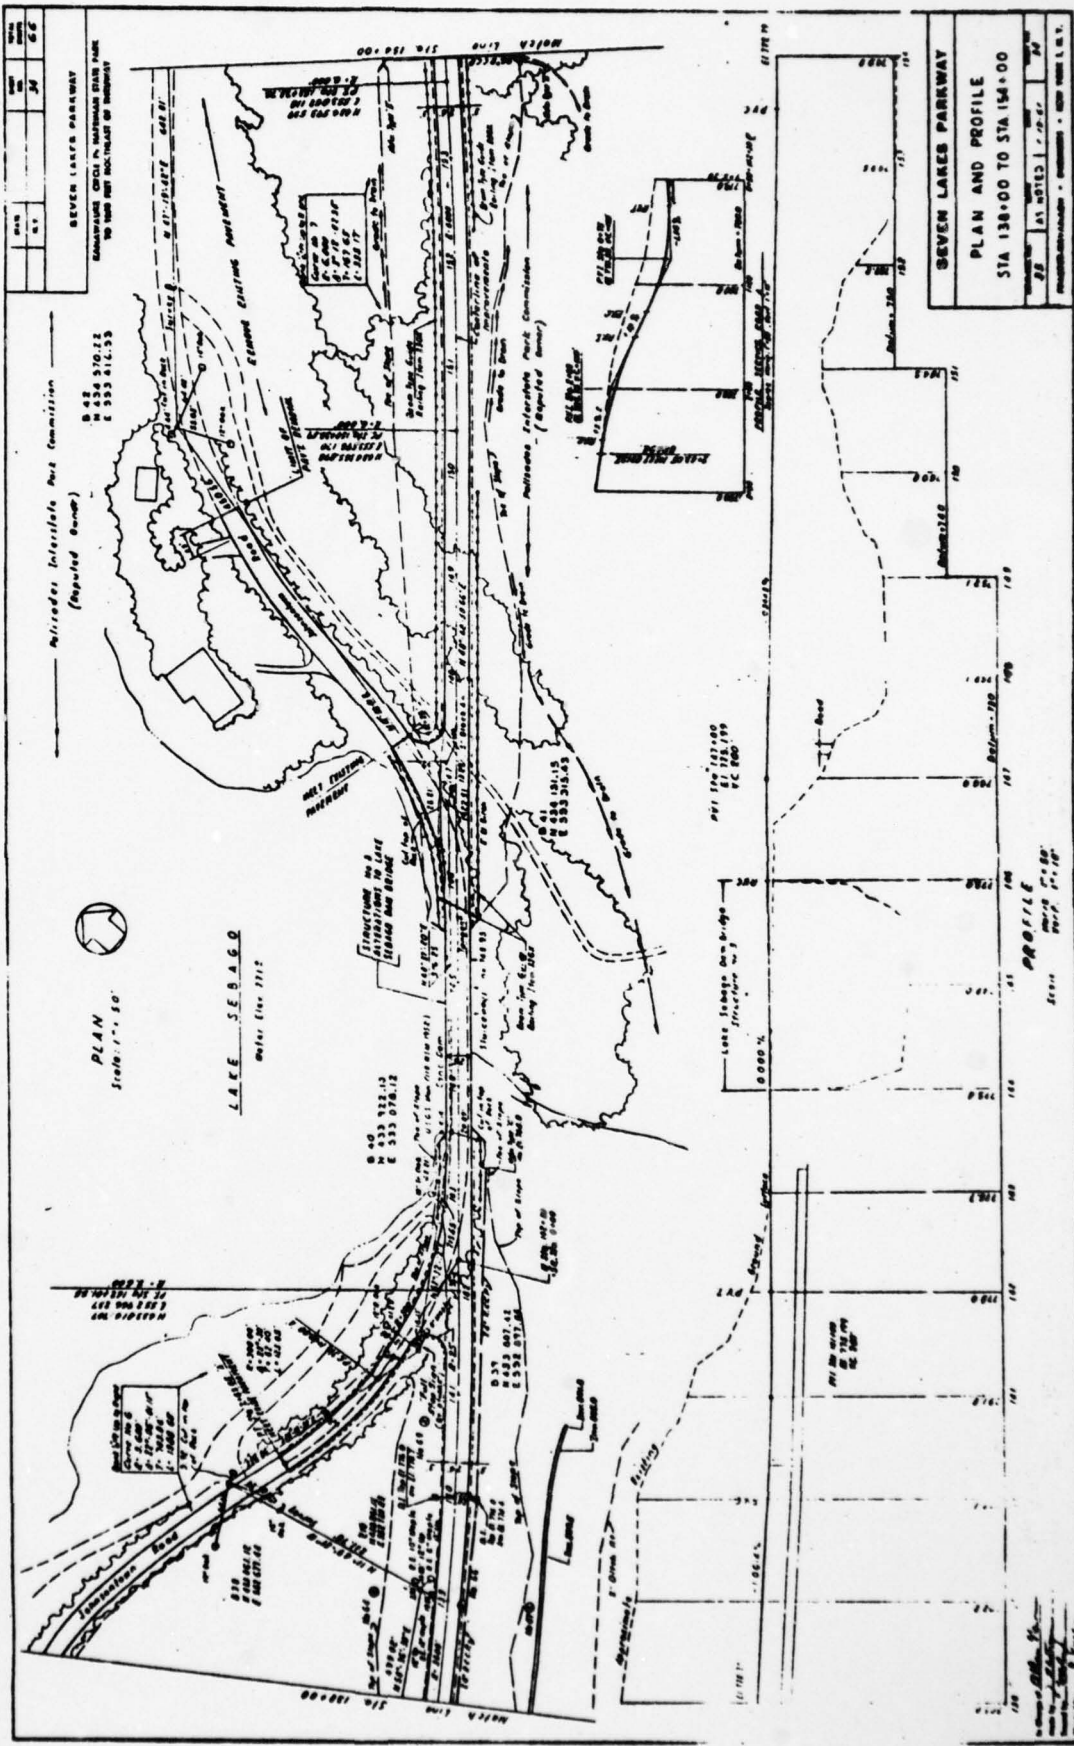
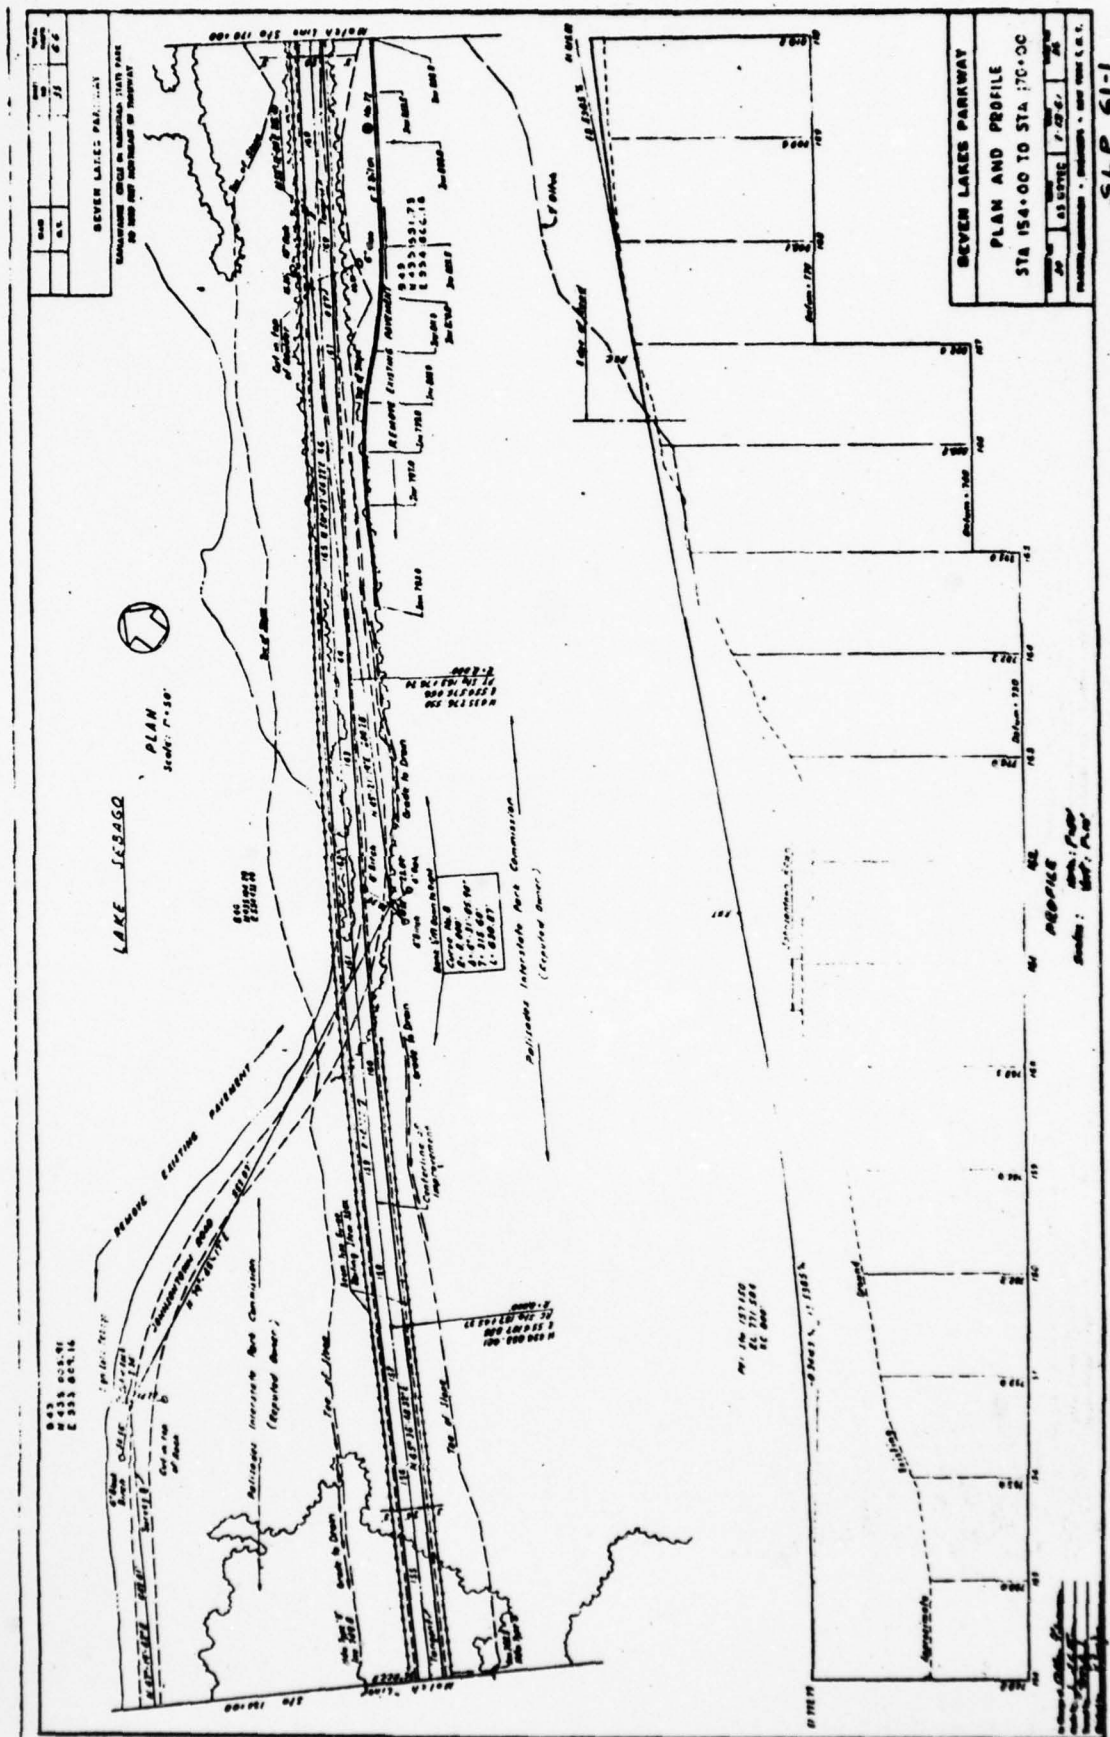
Figures 10 and 11 show plans for the new Seven Lakes Parkway (old Seven Lakes Parkway noted as Johnstown Road). The profile shows the depressed terrain between the old and new roadway. Currently, a large swamp exists in the area partly from runoff and partly from seepage of the dam's embankment. Overtopping of the dam would flood this area. A drain pipe (36" R.C.C.P.) at Station 154 + 00 could drain this area, but it is suspected it may not be able to sustain the 18 feet of head it would receive and could blowout causing a breach or failure in the road embankment. The adequacy of the road embankment is also unknown. Stations below 154 + 00 have a higher grade indicating that the road would not be overtopped.
